Manhole Inspection Summary

Manhole # S13C1_011MH

Insp Date: **3/5/08 10:01 AM**

Location Address: **3100 Georgetown RD**

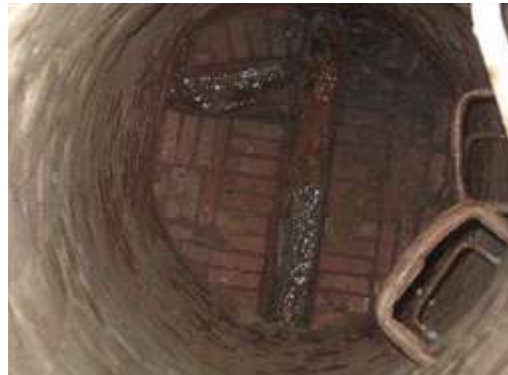
Top View

rusted top rung oxidated other rungs

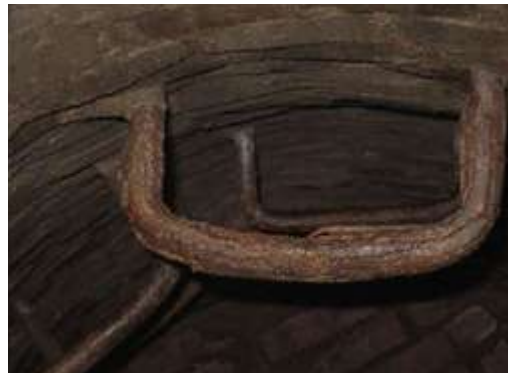
Defect 1

first rung rusted/ oxidized rungs

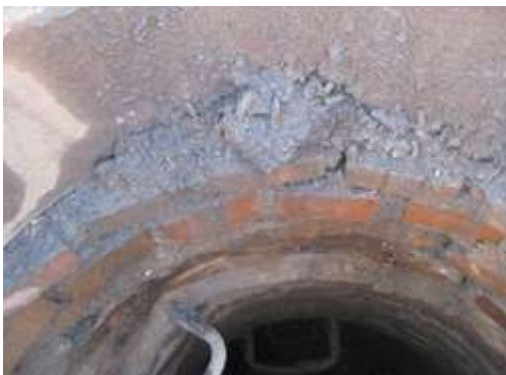
Defect 5

Offset: **2** (in.)

Frame Offset

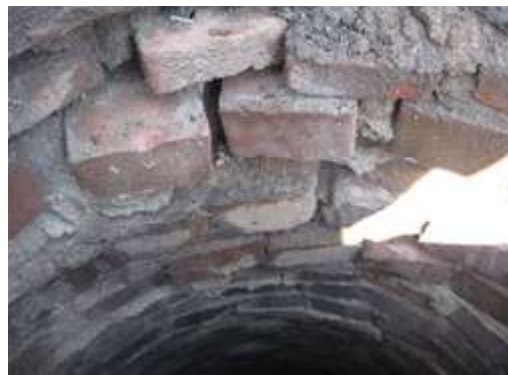
Defect 6

Condition: ☐ Sound ☒ **Cracked** ☐ Root Intrusion ☒ **Loose Brick** ☒ **Deteriorated**

Cracks and Loose Bricks in Chimney

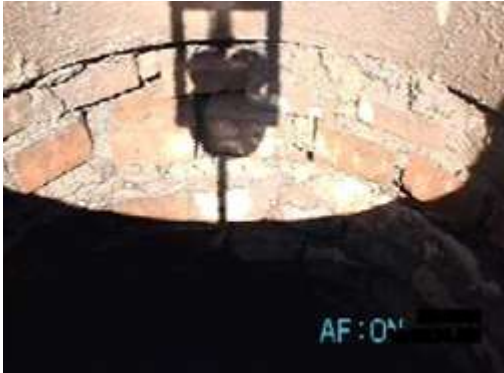
Defect 4

Deteriorating Chimney

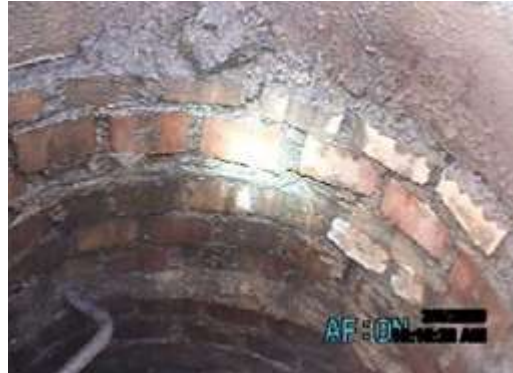
Defect 3

infiltration frame - chimney connect corbel

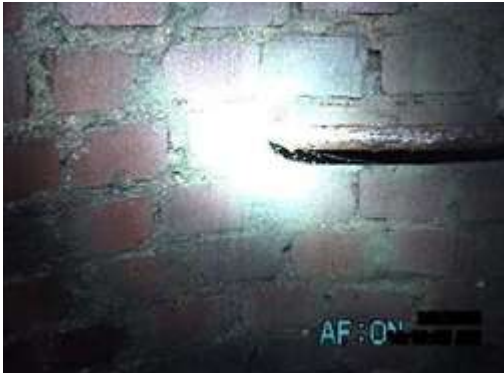
Defect 2

rusted rung, and corbel infiltration

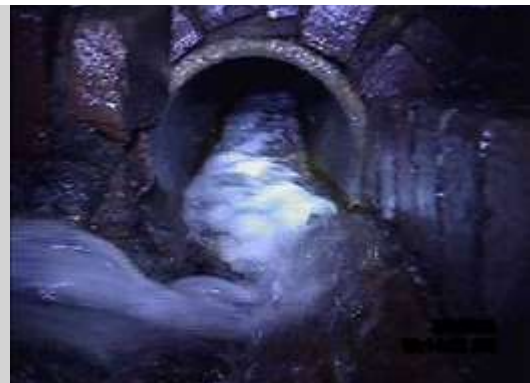
12 O'Clock Outflow

Pipe Height: **8.4** (in.) Rod and Bar (Angled)
Pipe Material: **Clay** ☐ Pipe Lined
Invert Depth: **12.20** (ft.) Flow Characteristics: **Fast**
Deposits: ☒ None ☐ Mud ☐ Sludge ☐ Debris ☐ Grease
Silt Depth: **0** (in.) Deposits Extent:
Infiltration: **None** Pipe Seal Cond: **Sound**

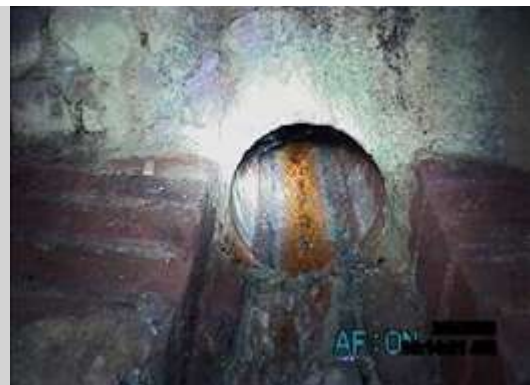
6 O'Clock Inflow

Pipe Height: **8.4** (in.) Rod and Bar (Angled)
Pipe Material: **Clay** ☐ Pipe Lined
Invert Depth: **11.82** (ft.) Flow Characteristics: **Slow**
Deposits: ☒ None ☐ Mud ☐ Sludge ☐ Debris ☐ Grease
Silt Depth: **0** (in.) Deposits Extent:
Infiltration: **None** Pipe Seal Cond: **Sound**

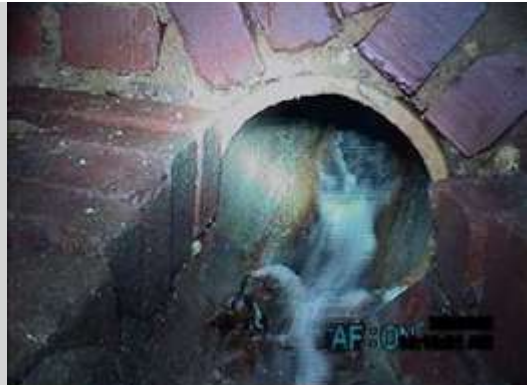
10 O'Clock Inflow

Pipe Height: **8.4** (in.) Rod and Bar (Angled)

Invert Depth: **11.58** (ft.) Flow Characteristics: **Fast**

Infiltration: **None** Pipe Seal Cond: **Sound**
